STUDY AND SURVEY OF SCHOOL FACILITIES

STANWOOD - CAMANO SCHOOL DISTRICT

Study and Survey

07 APRIL 2017

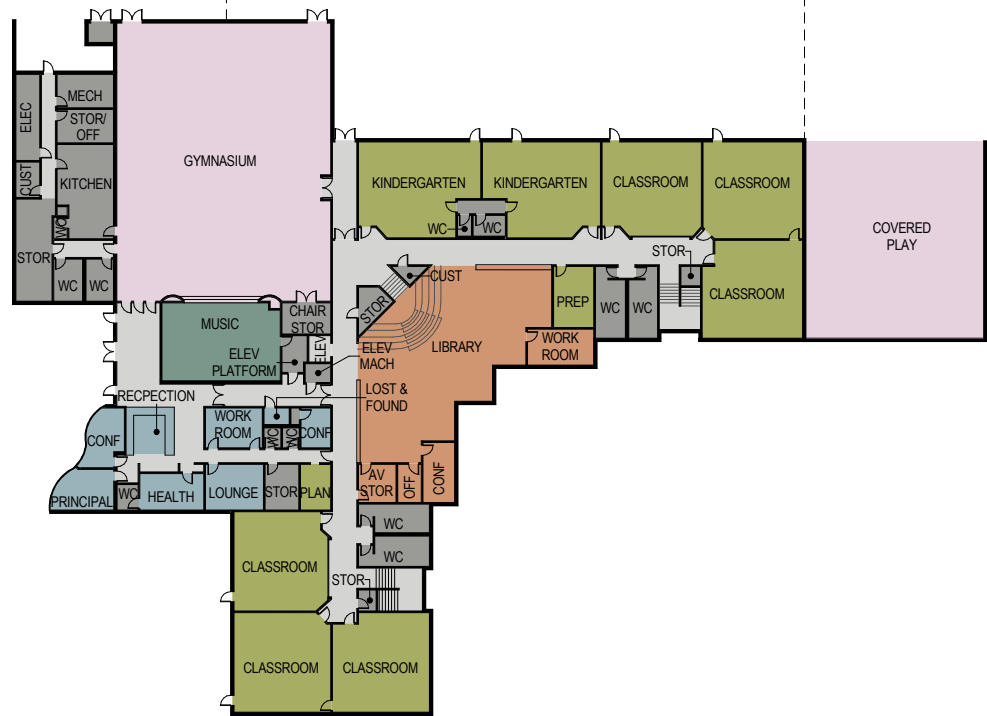
FIRST FLOOR PLAN

- GENERAL EDUCATION CLASSROOM : 17
- SPECIAL EDUCATION CLASSROOM : 2
- ARTS & MUSIC : 1
- LIBRARY
- TECHNOLOGY : 1
- ADMINISTRATION
- GYM, COMMONS, CAFETERIA : 1
- COVERED PLAY
- CIRCULATION
- BUILDING SUPPORT

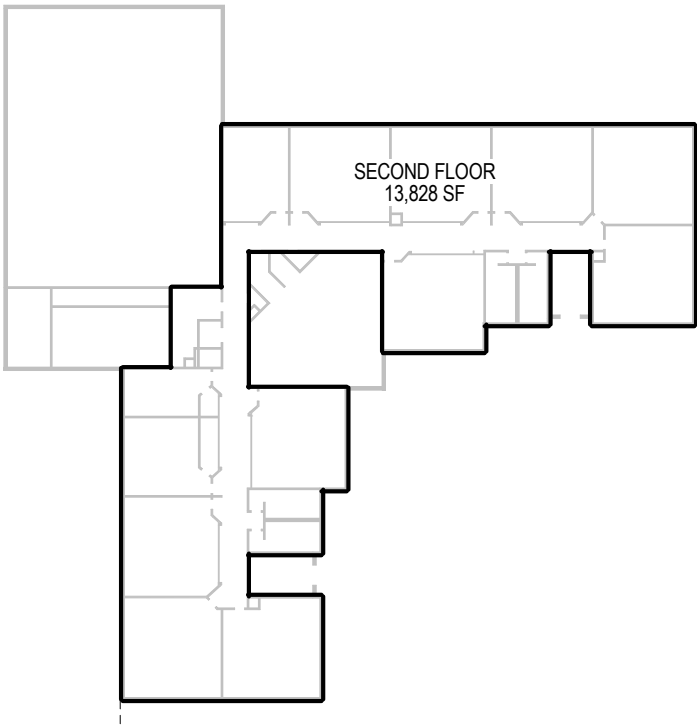
SECOND FLOOR PLAN

SECOND FLOOR	13,828 SF
13,828 SF	
TOTAL	41,824 SF

*COVERED PLAY COUNTED AT HALF.
